3) Strip condition of S2 RHS axle and spacer

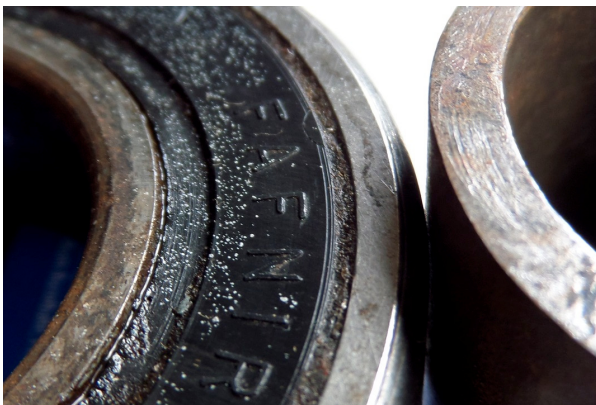
I looked carefully at a selection of old parts that I've run in my Lotus, also some photos from the internet. The parts discussed were taken from the RHS of my S2 Europa. They had completed 42k miles in my tenure and most probably were the originals, covering a likely total of 92k miles. They have never been allowed to come loose during my ownership and by chance have always been re-assembled with the spacer the same way around.

Left, outer bearing less face seals, also showing spacer mating face
