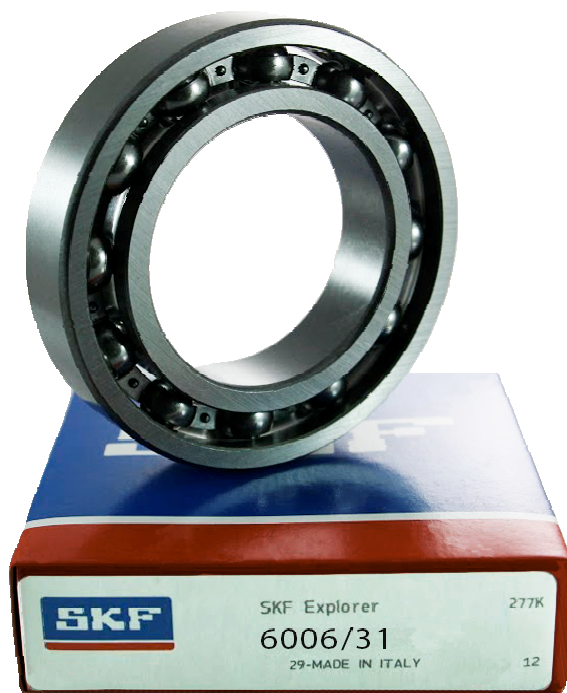
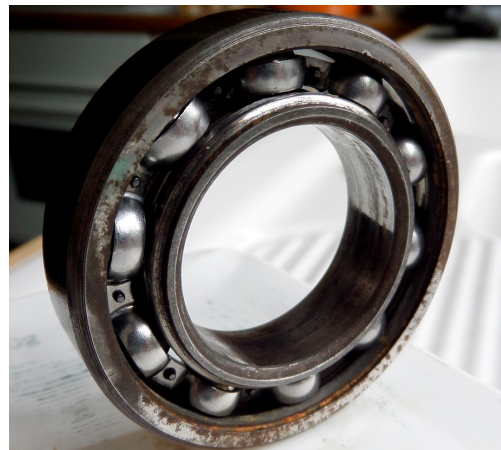
The solution best suited to a DIY home approach is to use the Hillman Imp inner bearing 6006/31 which doesn't have a reduced abutment area to accommodate the bearing seals, see comparison pictures following. The one on the right is the S2 Europa type with seals popped out. This mod requires that a grease reservoir be created, described in the earlier recommendation section of this report.

The ultimate cure is to stop the axle to inner bearing mating face deforming, by using one of two methods, both relying upon increasing the area of contact and thereby lowering the contact stress.
