## Chassis Heater Tube Replacement

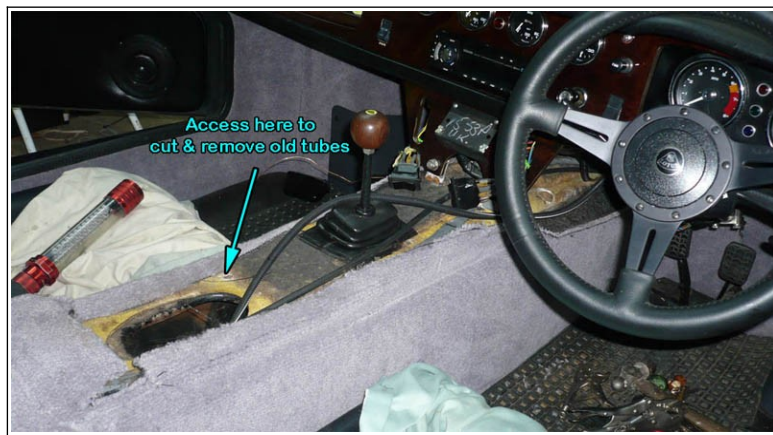
Pic 1 : Access to remove the old tubes

Instead, go inside the cabin, remove the centre console and go in through the hole in the chassis spine where you adjust the handbrake cable. The tubes are at the top of the chassis spine so you can't see them, but you can feel them and with a suitably small crowbar (sometimes referred to as "a screwdriver") it's possible to bend the tube to such a position where you can see it and get a hacksaw blade on it.

Once the tube has been cut through you have much better leverage and it's now very easy to twist, break the tack welds and pull out two very rusty tubes into the cabin.

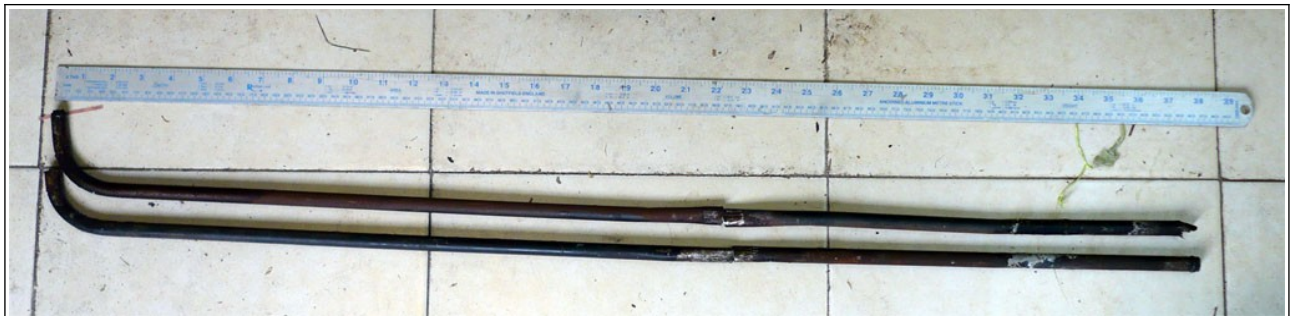
Pic 2: both heater tubes as removed.

That's a 1m ruler so they would have been roughly 38"/95cm when new. I'm sure that's a very arbitrary measurement and could easily imagine +/- 5cm on that. The OD came in at 12.5mm, so 1/2" in sensible units.

Whilst there was internal corrosion and thinning, the main problems were at the ends, the swaged portions had either gone completely or started to pinhole. The initial failure was the inlet tube falling apart just after the swaged portion causing the hose to come loose. I'd take the condition of the swaged ends as a good early warning indicator of whether or not you should be considering replacements.

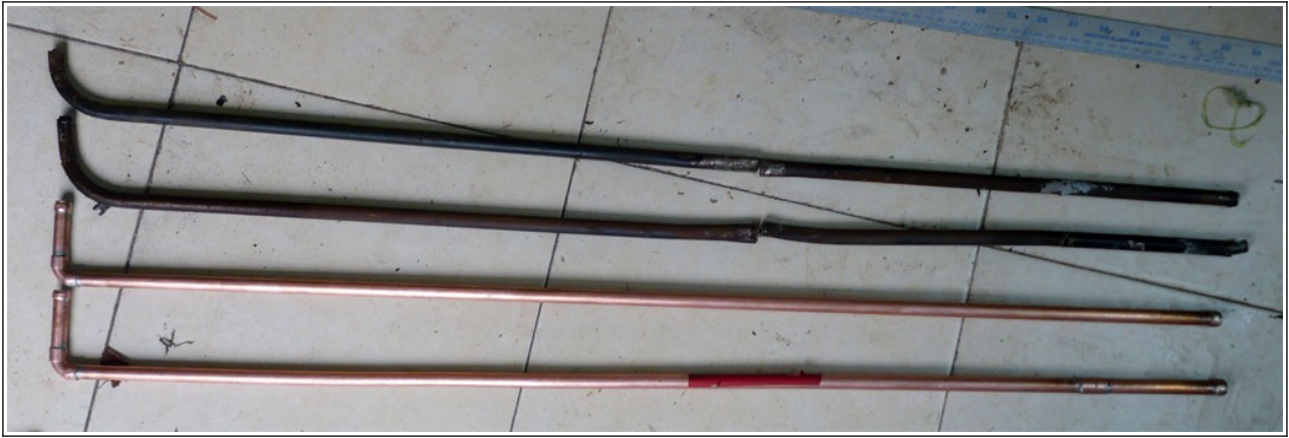
Pic 3: Old & New tubes.

The new copper tubes were made fractionally shorter than the originals. I've always found that the short return hose to the water pump pipe is a tight fit, so a bit more room to flex the tube might be helpful.

Instead of swept bends at the heater end, I used 90deg copper fittings to turn that corner. To replicate the swaged ends (which had all but rusted away) I soldered the 12mm olives in place, simple & effective.

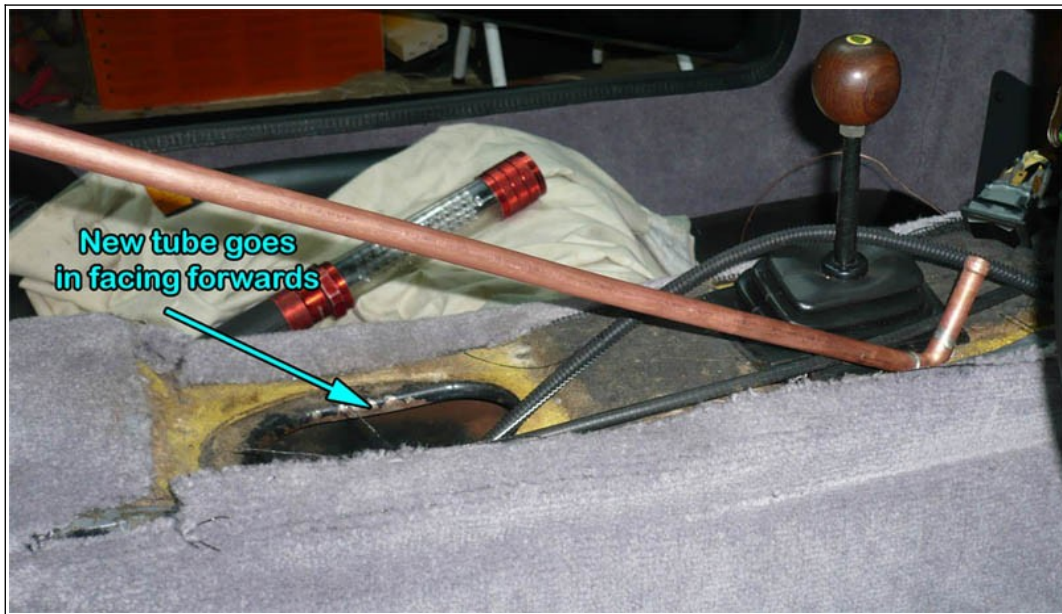
Pic 4: Tube replacement.

With both doors open there's enough room to angle the replacement and get the heater connection inside the tunnel. Then gradually feed the tube in, swinging it around as you go. No need to bend the tube and there's enough room in the central spine to push the complete length in and then feed it backwards to go through the holes in the rear closing plate on the chassis spine.

Once you're located in the closing plate it's a case of trial and error to get the heater connection through the front hole. After several minutes of blind fiddling about I realised it might be a good idea to mark the length from the access hole to the heater holes and after that stroke of genius (or maybe just "doh" ?) the tubes went in easily.

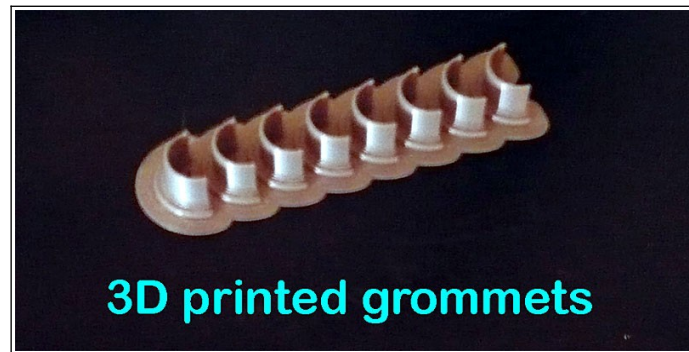
The ID is sized at 12.5mm diameter with a tapered outside so it's like sliding a cork in place. They worked remarkably well, just pushing them into place from the engine bay and inside the cabin, tapping with that universal tool (screwdriver) to get them nice & tight..

I used PLA+ which has a softening point of around 55C so they may distort in service, we'll just have to see how they go. If it looks like they're coming loose/distorting then I'll use a higher softening material for the next set and that should be good enough.
