This may or may not be helpful to updating the shift linkage on a 365 transmission.

The Europa had been sitting for about 40 years. The shift linkage was sloppy and I could not engage 5th with the shifter, even though I could by rotating the rear U joint by hand. Theoretically, it meant the linkage was poor and the transmission was OK. The purchased part number references are from RD Enterprises.

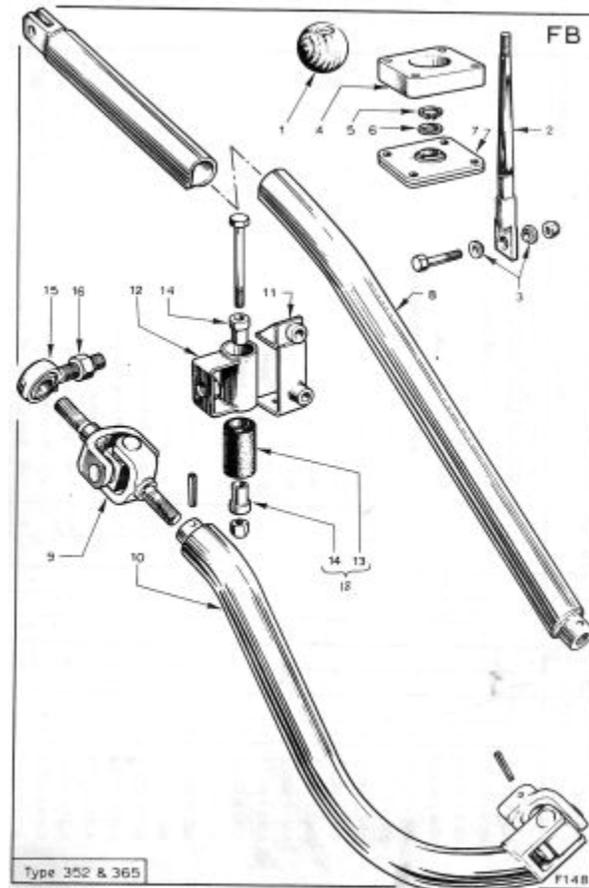
I looked at the OEM parts list in the service manual:

I decided I needed parts #3 (RD # 46F6153BA Bolt w/bushes & nut \$26.00), #13 (50C6042 \$25.55 each) and it's bushes (74F0219 \$8.00 each (2 per car)) to get me going. If you're lucky enough to have the service manual it somewhat vaguely describes how to remove the shift linkage. There is additional help on line and I find this - [Lotus Europa Community - Index](#) to be a pretty good source. However, neither of those told me I needed very skinny arms and long fingers with the strength of 10 men but I suppose that is a given when working on a Lotus.

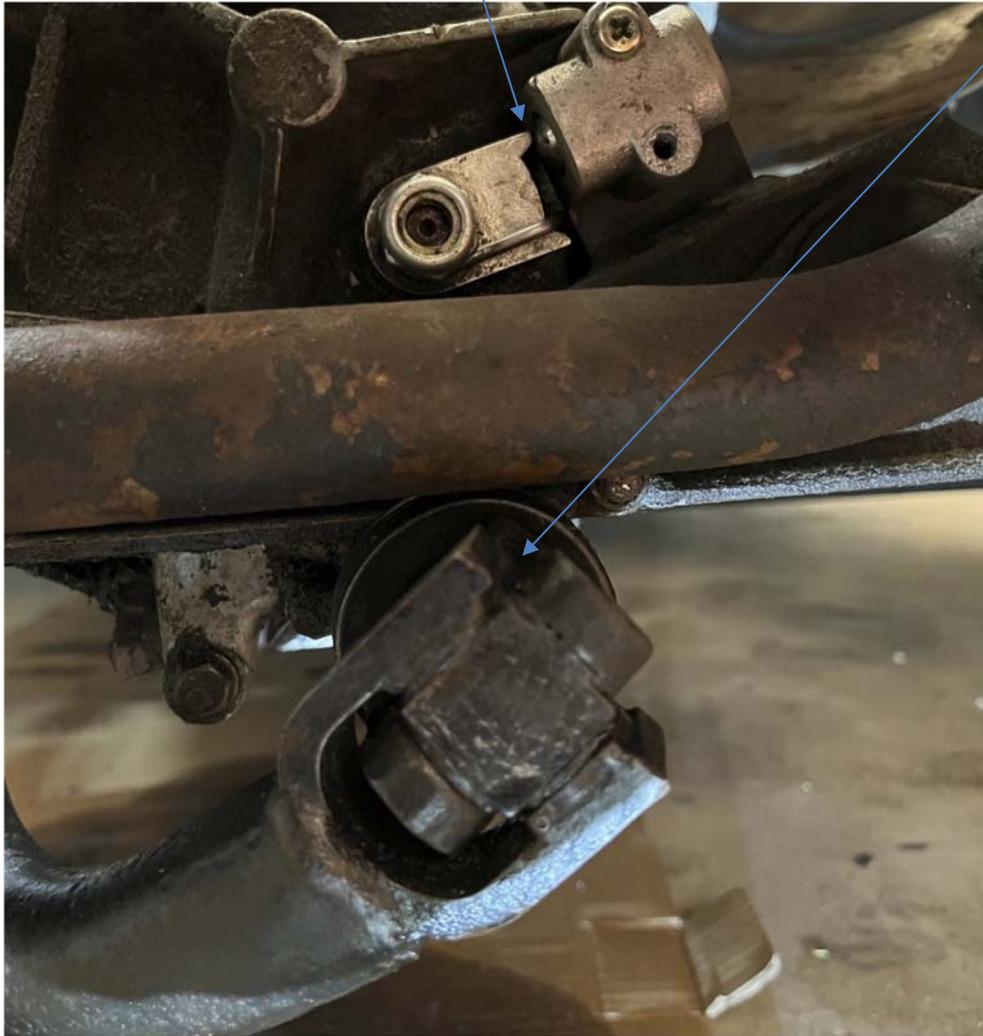
The issue with not being able to get to 5th gear had to do with the clocking of the transmission to depress the 5th gear detent at the back of the transmission.

This is in reverse with the reverse detent depressed.

To get to 5th the transmission needs to be moved clockwise far enough to depress the lower detent

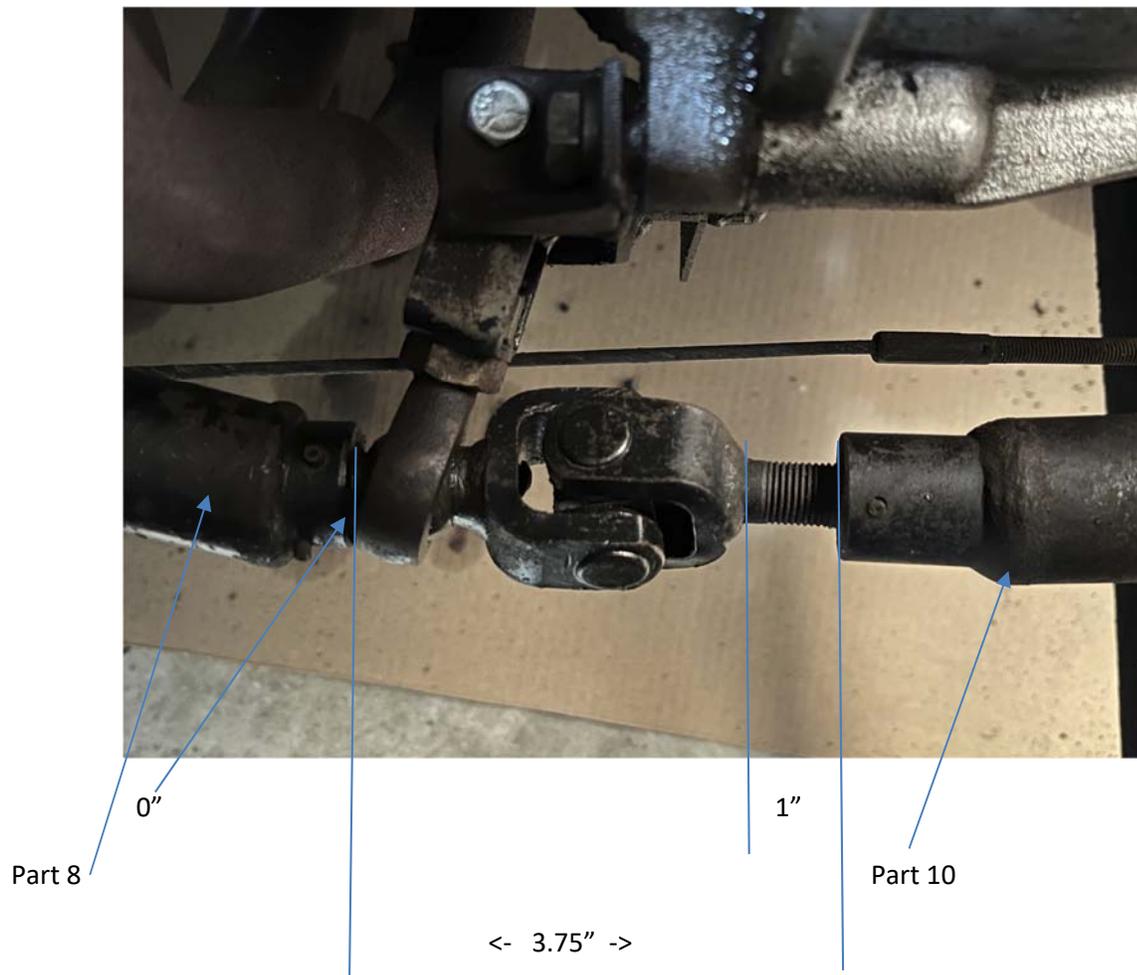
Generally before I take anything apart I take pictures and measurements to make sure I can get back at least to where I started.

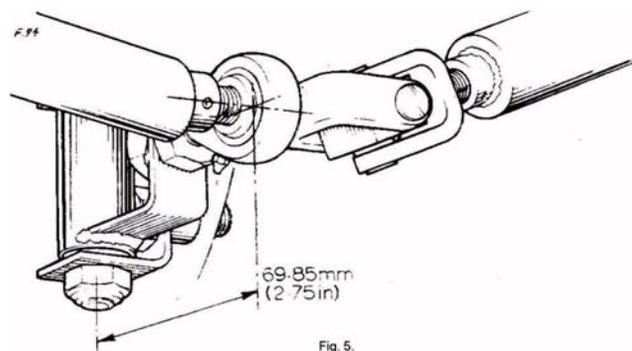
Trial fitting part 15 was next. It needed to be against the forward tube and the service manual states it needs 2.75" of throw from the center of the bolt holding it to the bellhousing bracket to the centerline of the U joint. My old one had that dimension as well.

Here the threaded end of part 15 was about $\frac{1}{4}$ " long to allow that to happen. Remove $\frac{1}{4}$ ", refit, done.

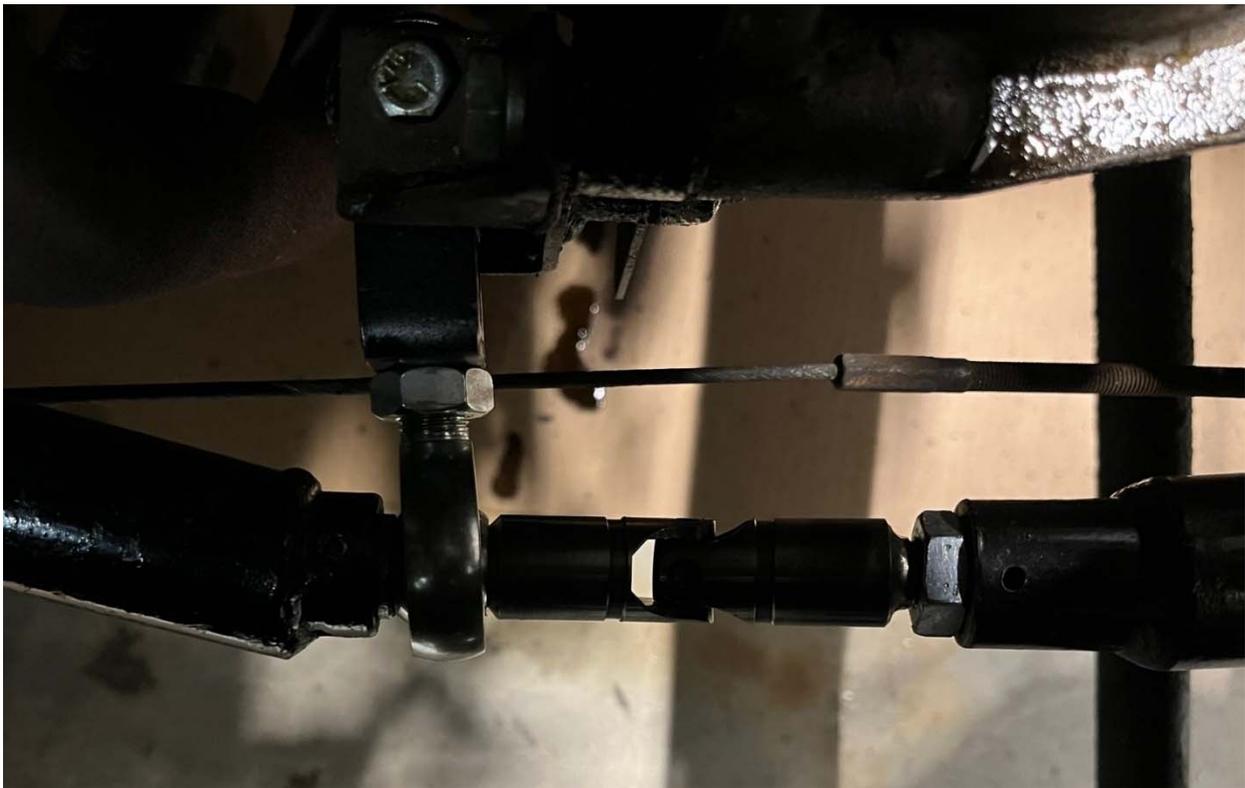
Put it all back together. I have the center u joint in with about $\frac{1}{8}$ " of adjustment left.

This conveniently gave me 360 degrees of rotation to be able to clock the rear ujoint correctly. The forward and rear tubes are together with the center U joint. Feed the forward tube in to the tunnel with the string as a guide – pull the string a little, push the tube a little. When the end of the forward tube appears in the cutout in the tunnel it was time to put the gearshift on the end of the forward tube. Using the new bushes (part number 3) from RD proved to be nominally challenging as the fit snugly as they are supposed to – takes a bit of work to get them together. Once done I pulled the gearshift through the center tunnel but didn't bolt it in place yet. Next I went to the center u joint and moved that roughly in place without bolting it. I then fit the rear ujoint to the transmission with the roll pin.

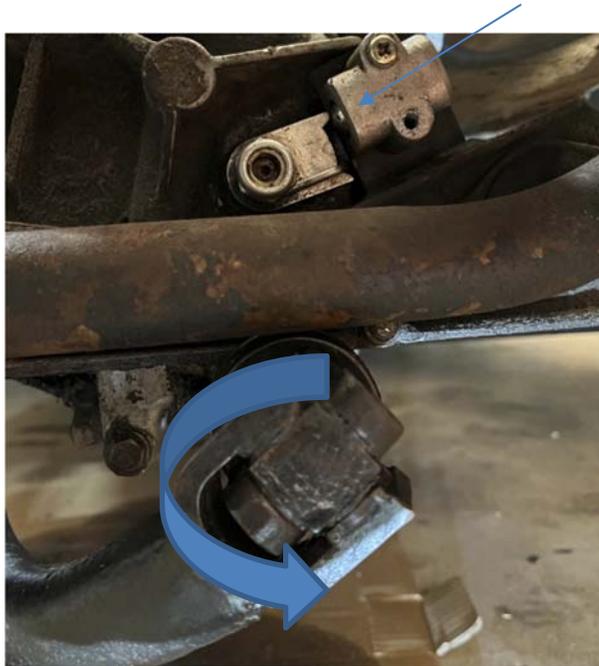
To get the clocking correct I set the gear shift in the approximate location of reverse. Remember the lock nut to the rear tube is still loose and allows that tube to rotate. Go to the ujoint at the back of the transmission and put it in reverse by hand moving that. Looked at from the back of the car the ujoint needs to be all the way in and all the way anticlockwise to depress the lockout.

I then tightened down the rear locknut. Got in the car. Shifted through the gears. Looked like I had them! Went for a ride and low and behold, all of the gears (including 5th) and it shifts crisply and smoothly!
