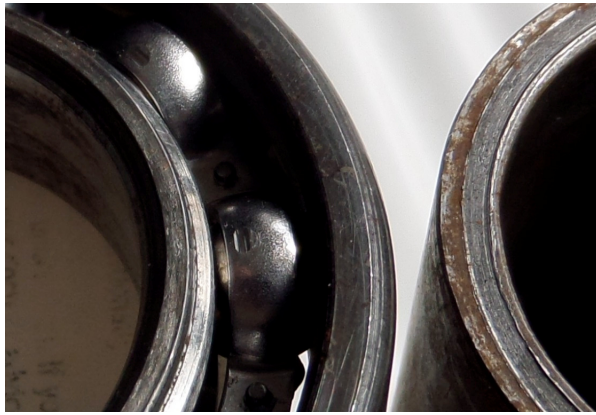
Left, inner bearing and spacer mating face

There is a noticeable difference between the inner and outer bearing spacer mating faces. The inner bearing has heavily marked the spacer actually displacing metal. This looks more like overload than fretting. The outer bearing has no such marking. This is down to differing stress levels, load being the same at both ends of the spacer.

A hardened spacer will not suffer significant wear or deformation and represents a good way to ensure the inner bearing does not damage the spacer, but we also have to consider the other end of the inner bearing inner race, the axle face, which sees similar stress levels.

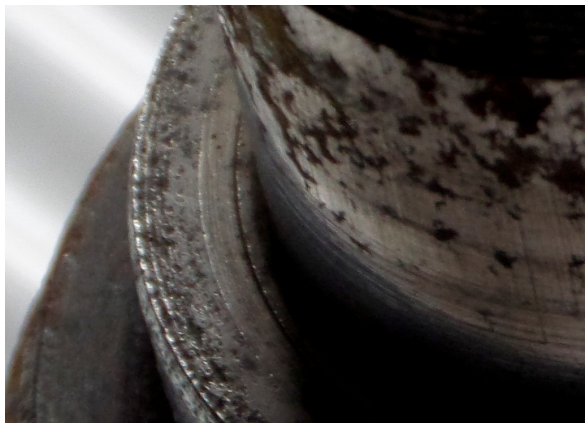
Left picture of the bearing abutment on the axle removed from the LHS of my Europa.

Quite clearly the inner bearing inner race has removed material where it has contacted the axle. Steve Veris did some hardness assessments of the axle and came up with 27R, on the C scale I assume. This equates to c.880MPa tensile strength, source:
