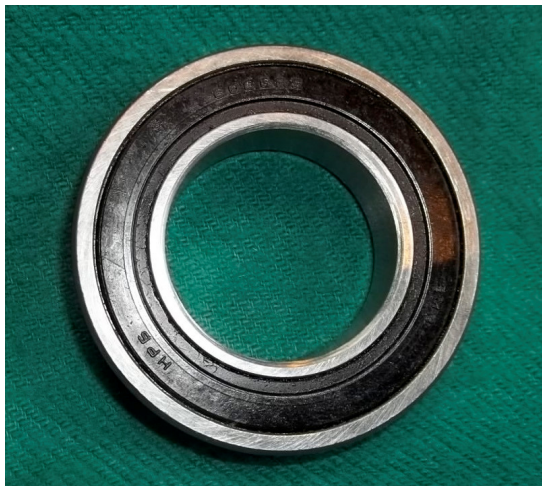
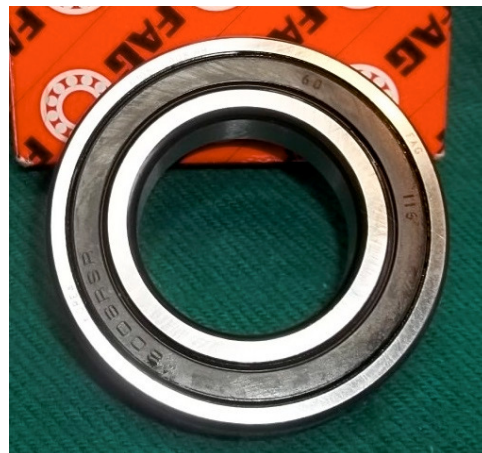
Turn the inner part of the axle down to 30mm and use the TC inner bearing, see below, S2 left, TC right. This will lower contact stress to well below yield for the axle material and should ensure maintenance of clamp load.
